# Technical Service Bulletin

## MIL on (DTC P0642, P2004, P2008, P3137, P3138 in ECM)

24 08 10 2016868/2 March 3, 2008. Supersedes Technical Service Bulletin Group 24 number 08-02 dated Jan. 17, 2008 to add a reference to RVU CH.

Model(s)	Year	VIN Range	Vehicle-Specific Equipment
A3	2005 – 2007	All	2.0 TFSI Engine
A4	2005 – 2007	All	
A4 Cabriolet	2007	All	
TT	2008	All

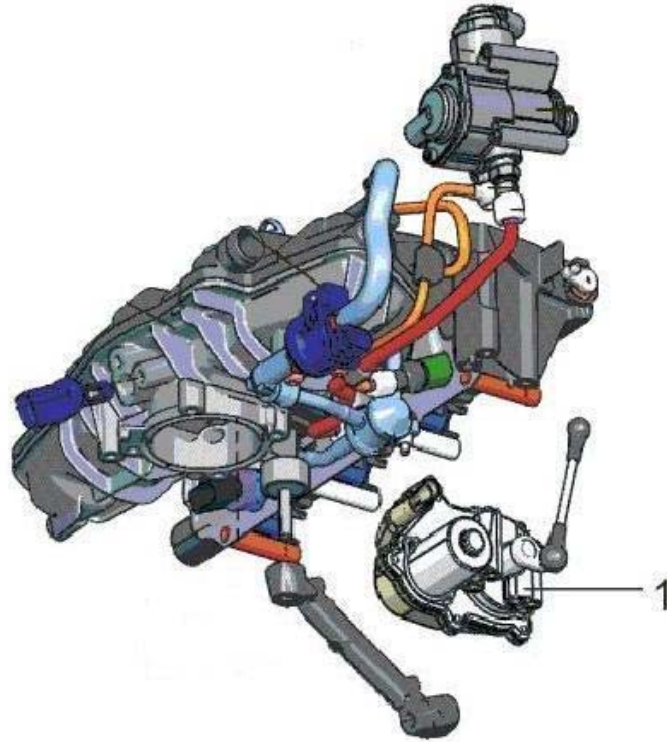
- ECM software.
- The Intake Flap Motor V157 or Intake Manifold Runner Position Sensor G336 may be inoperative. (Both are included in one single unit.)

**Figure 1.** The Intake Flap Motor V157 (1).

5. Perform basic settings for Intake Flap Motor V157 (channel 142).
6. If the basic settings for Intake Flap Motor V157 cannot be performed successfully, replace the Intake Flap Motor V157.
7. If one or more of the DTCs listed in the condition section are stored in the ECM data memory and the ECM SW was previously updated (the ECM already has the new SW version), replace the Intake Flap Motor V157 even if the basic settings can be performed successfully.
